RE: Preliminary Assessment for **Sitkinak Loran A Station**
AK5141190087

Encl: Preliminary Assessment for Sitkinak Loran A Station

PRELIMINARY ASSESSMENT SITKINAK LORAN A STATION

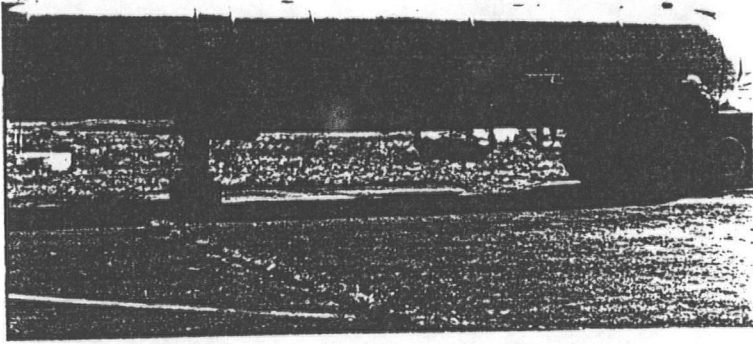
View looking west of the fuel oil storage tanks. The discharge of contaminants from both the storage tanks & the sewage treatment plant has adversely effected the stream. Several oily deposits can be seen throughout the portion of the stream.

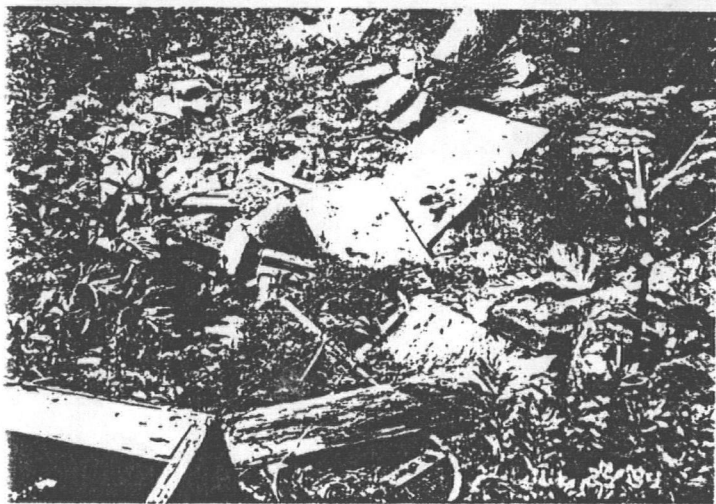
Same trash pile different
view.
